## Inductive Logic Ltd Warranty Information Sheet Product Number: MD800P

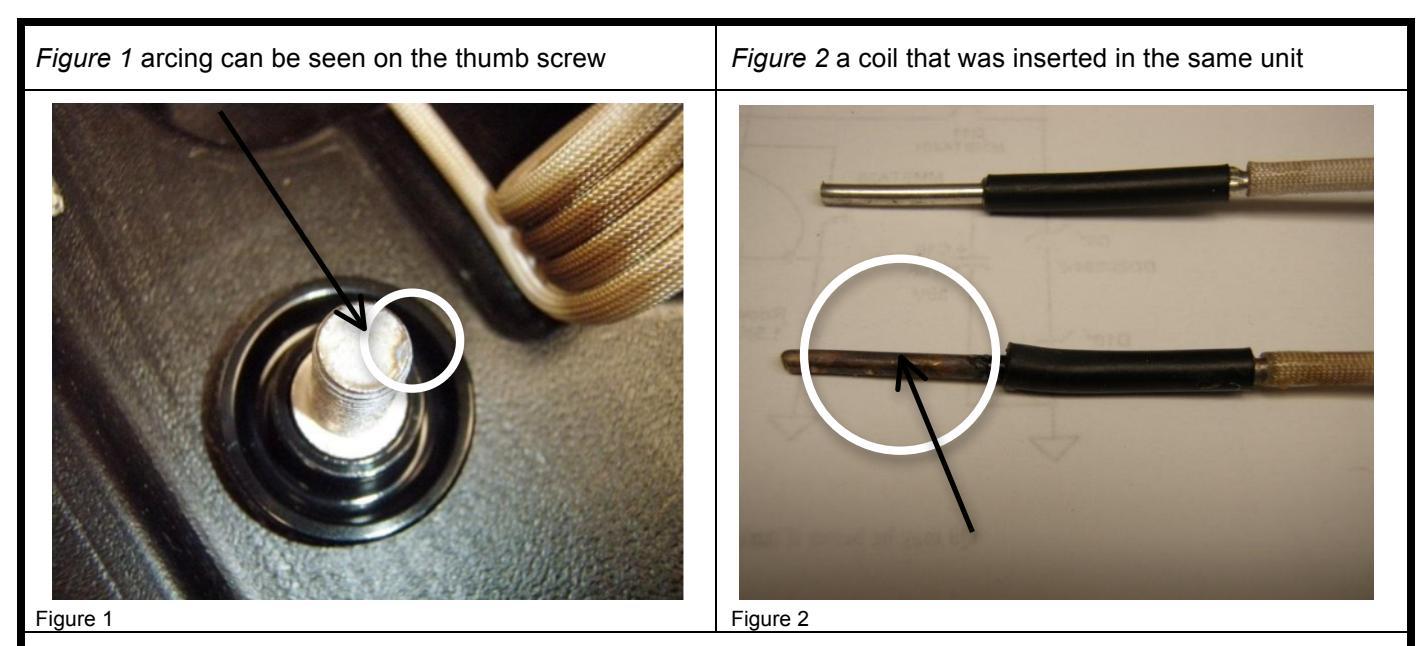
Notice on the coil (*Figure 2*) the carbon build up on the lower leg of the coil. This is caused by the thumb screws not being tight enough; thus a loose connection on the coil or attachment. This condition can cause damage to the Unit, poor heating performance, damage to the isolation transformer, and premature wear on the coil and *is not covered by warranty*.

*Figure 3* shows a housing that was melted were the coil is inserted. This can be caused from a loose coil, overheating of an object or running the product with no load or a non-ferrous load. Because of this the coil starts to overheat and damages the housing.

- 1. Always tighten the thumb screws correctly
- 2. Never run unit with no load or nonferrous material
- 3. Do not use damaged coils with no insulation
- 4. Do not over heat items (If it is red hot it is too hot)

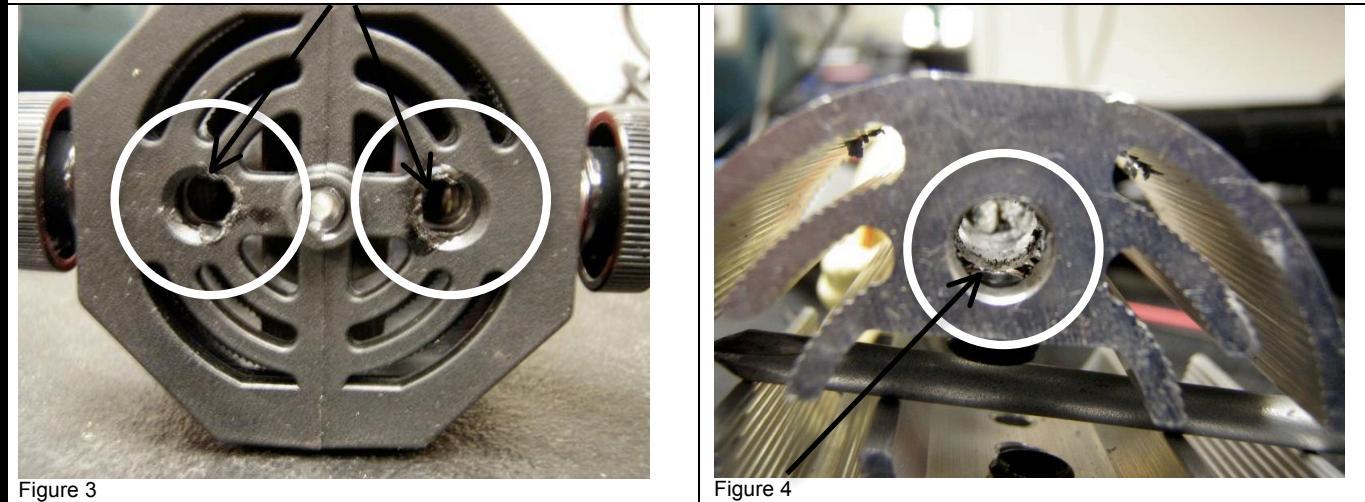
*Figure 4* shows an HDT that has been used with a loose coil. The inside contact point of the HDT shows the coil heat shrink tubing has actually melted and is preventing a good contact between the coil and the HDT. As a unit is used occasionally he HDT and thumb screw should be checked for foreign substances that prevent good contact between the coil, HDT and thumb screw.

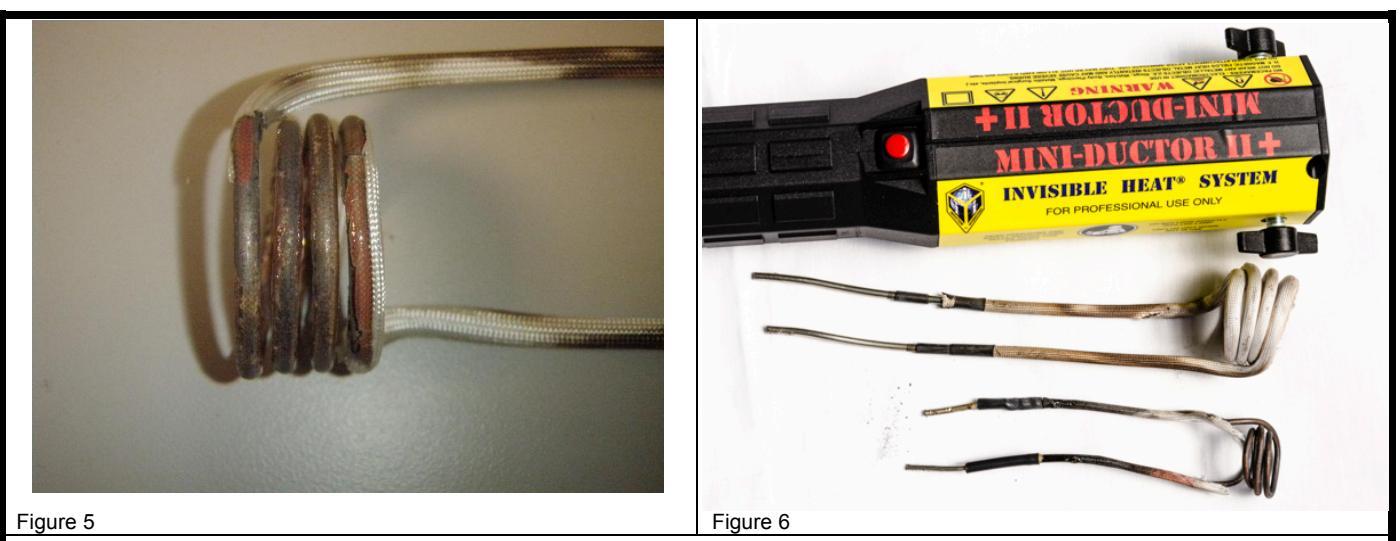
*Figures 5 & 6* show coils that have been abused way beyond their service life. The insulation on the coils is no longer present and the copper shows signs of overheating. Remember that one should apply only enough heat to break the bond of adhesives or loosen hardware for corrosion there is no need to heat items red hot.

Once the load is heated to red hot the item is no longer conductive and the energy created starts to overheat the coil and break down the insulation. Continued use will then make the coil red hot destroying the coil and potentially damaging the unit. Overheating the copper coil also changes the property of the copper and makes it less effective. Once the insulation is breached the coil should be be removed from service.

Damage to the unit that is caused by overused coils is not covered under warranty.
